DEPARTMENT OF TRANSPORTATION**DIVISION OF ENGINEERING SERVICES**

Contract #: 04-0120F4Cty: SF/ALA Rte: 80 PM: 13.2/13.9File #: 69.28**WELDING INSPECTION REPORT****Resident Engineer:** Pursell, Gary**Address:** 333 Burma Road**City:** Oakland, CA 94607**Report No:** WIR-006293**Date Inspected:** 14-Apr-2009**Project Name:** SAS Superstructure**OSM Arrival Time:** 1845**Prime Contractor:** American Bridge/Fluor Enterprises, a JV**OSM Departure Time:** 645**Contractor:** Zhenhua Port Machinery Company, Ltd (ZPMC), Changxing Island **Location:** Shanghai, China**CWI Name:** See Below**CWI Present:** Yes No**Inspected CWI report:** Yes No N/A**Rod Oven in Use:** Yes No N/A**Electrode to specification:** Yes No N/A**Weld Procedures Followed:** Yes No N/A**Qualified Welders:** Yes No N/A**Verified Joint Fit-up:** Yes No N/A**Approved Drawings:** Yes No N/A**Approved WPS:** Yes No N/A**Delayed / Cancelled:** Yes No N/A**Bridge No:** 34-0006**Component:** Tower Fabrication**Summary of Items Observed:**

Tower Bay 11

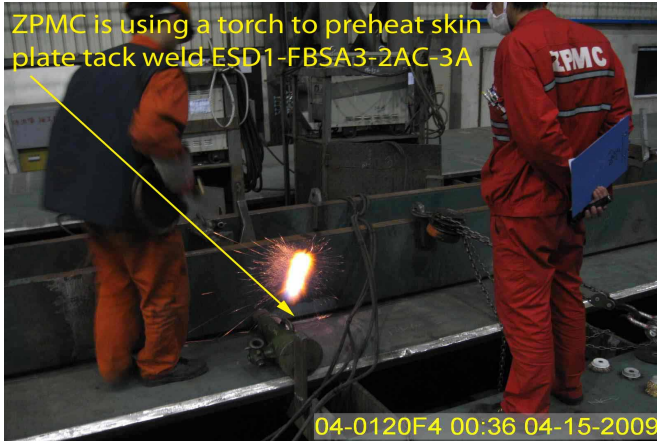
This QA Inspector observed ZPMC welder Mr. Huang Guo qi, stencil 059525 is using flux cored welding procedure WPS B-T-2232-TC-U5F to make stiffener to skin plate tack weld ESD1-FBSA3-2AC-3B, and ZPMC welder Mr. Li Zhao qian, stencil 048810 is using flux cored welding procedure WPS B-T-2232-TC-U5F to make stiffener to skin plate tack weld ESD1-FBSA3-2AC-3A. The QA Inspector observed the base material being preheated using a torch and that ZPMC QC representative Mr. Cao Cheng monitoring these welds. The QA

Inspector asked Mr. Cao Cheng what welding current and voltage he had previously observed for the welds that had been made and Mr. Cheng showed the QA Inspector that his clipboard weld monitoring sheet only listed the welders' identifications, welding procedure and weld numbers but it had no welding current or voltage. Mr. Cheng also said he had to walk to his office to get a welding amperage measuring probe. A few minutes later Mr. Cheng returned with a welding amperage measuring probe and he measured Mr. Li Zhao qian having a welding current of 295 amps and 26.5 volts. The QA Inspector measured the welding current of Mr. Huang Guo qi to be 285 amps and 34.4 volts. The QA inspector informed Mr. Cheng that Mr. Guo qi appears to have excessive welding voltage and Mr. Cheng measured and agreed the voltage was too high, and Mr. Cheng decreased the voltage to approximately 31 volts. Items observed by this QA Inspector do not appear to be fully progressing in compliance with project specifications. See the photograph below showing ZPMC using a torch to preheat the base material where the tack weld is to be deposited.
